Crack Detection on County Roads with Mobile Cameras

NADim Seminar – Norsk Asfaltforening

Madhavendra Sharma
PhD Candidate, NTNU

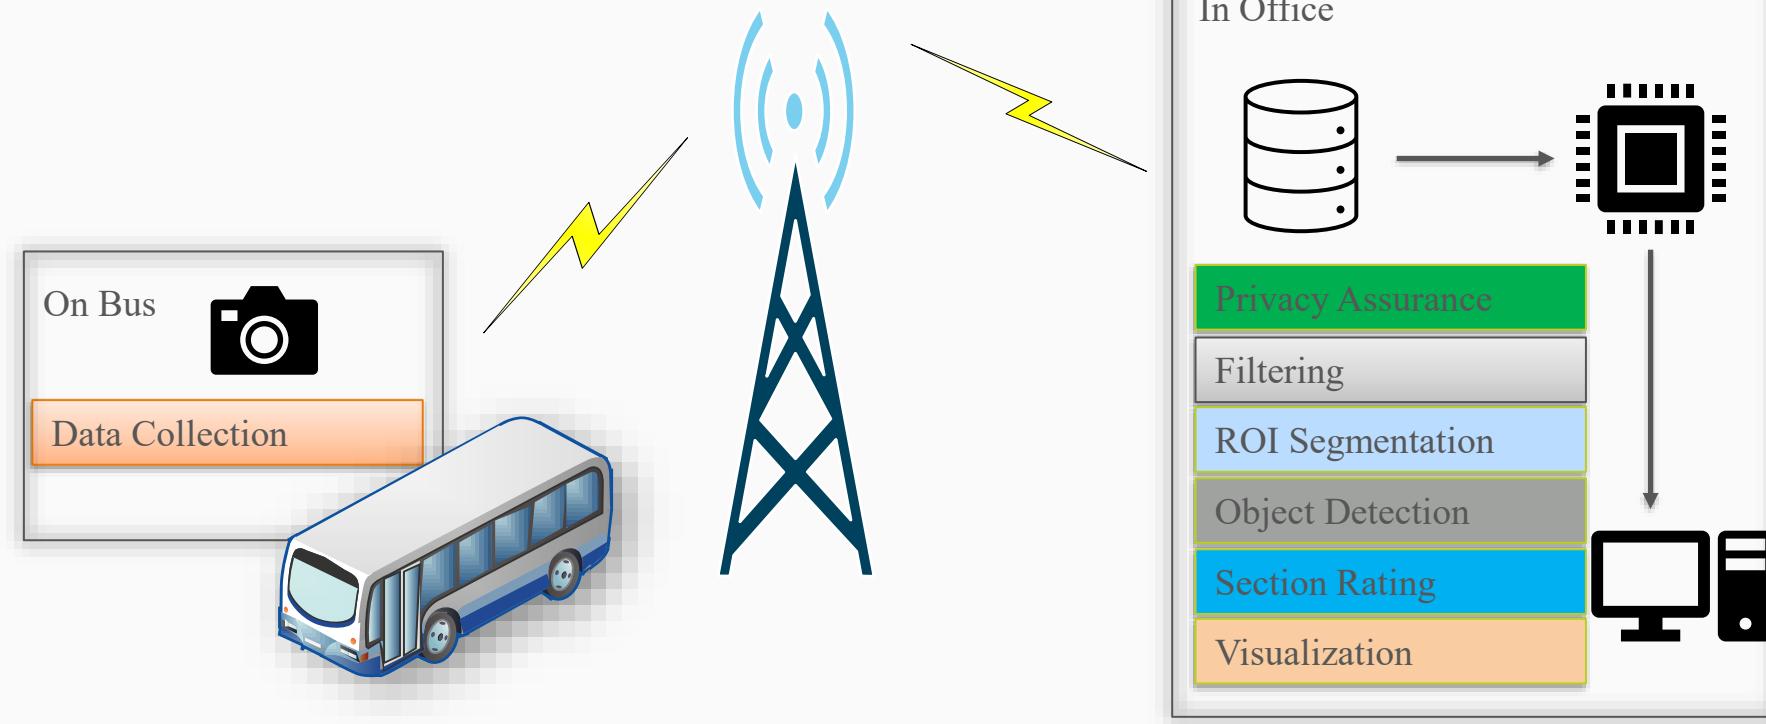
AI Models : Automatic Damage Detection

- Full automation

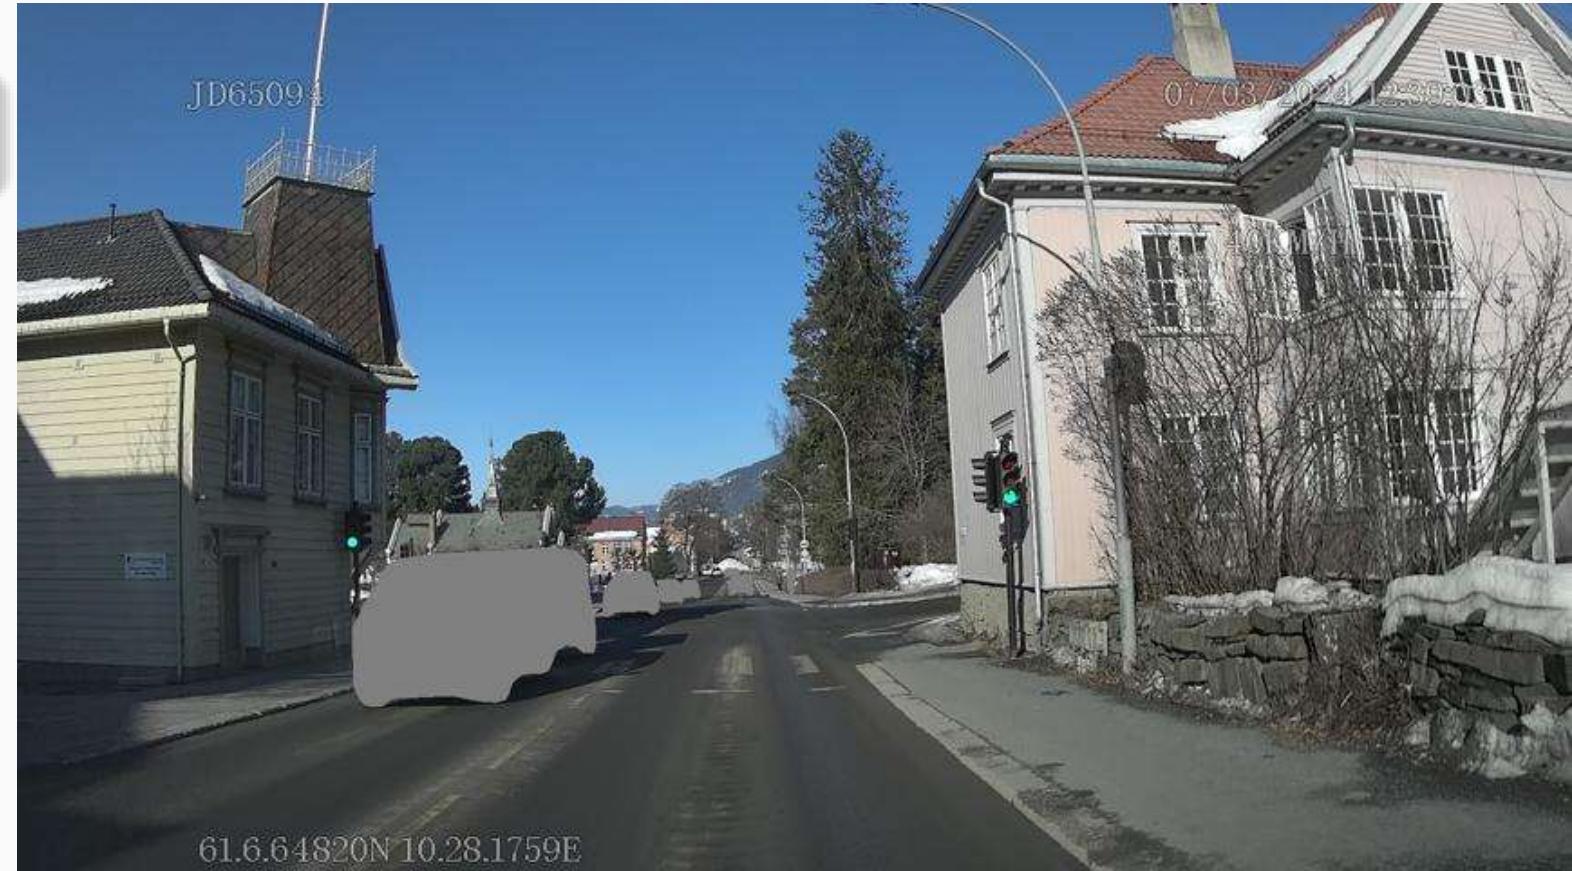
Privacy Assurance

- Mask Personally Identifiable Information (PII)
- **Mask2Former** Model pretrained on MS-COCO

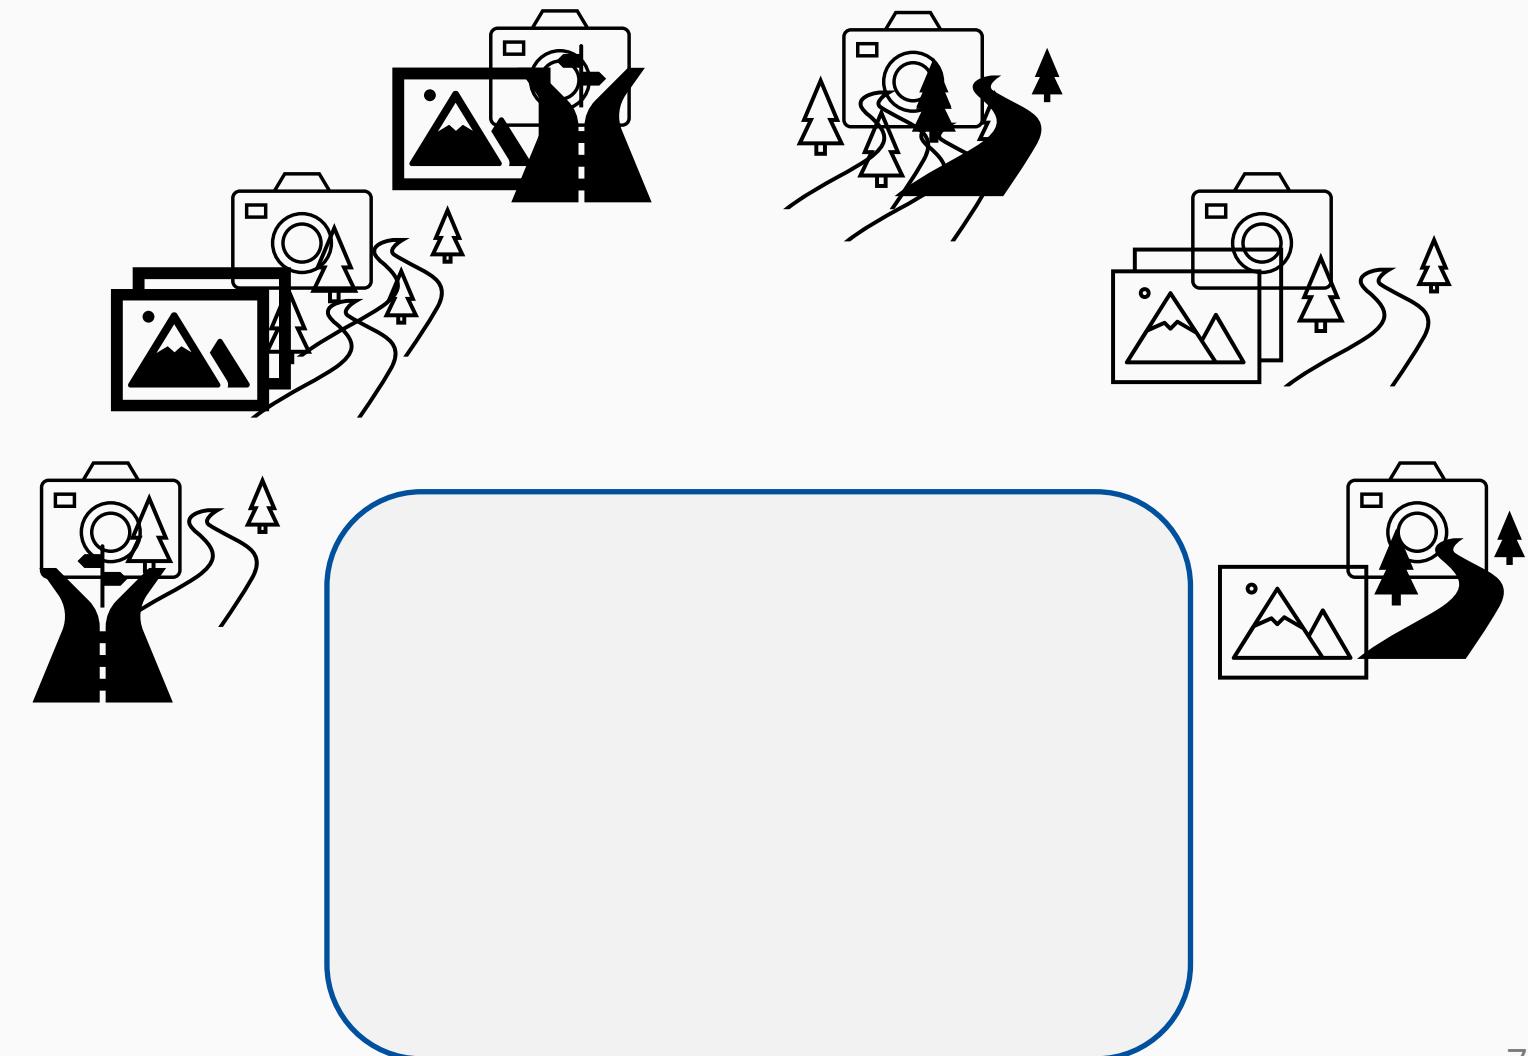
Filter Model

WHY?

- Multi-Level Custom Model
- **Unsuitable image**
- **Segment Road surface**

Factors Considered:

- Road Presence
- Weather
- Lighting Condition
- Road Surface

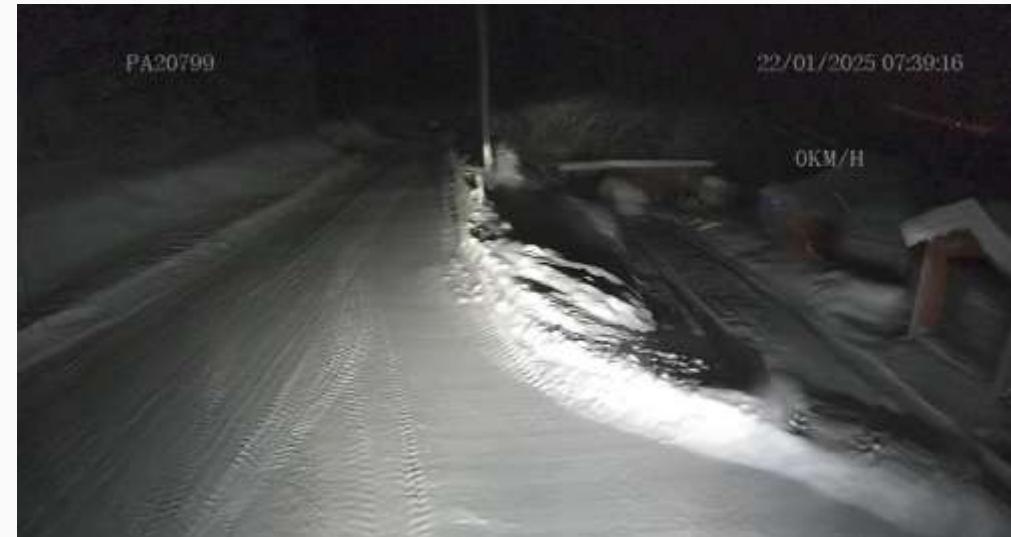
Filter Model

- Multi-Level Custom Model
- **Unsuitable image**
- **Segment Road surface**

Unsuitable Images
DELETE

Suitable Images
SAVE

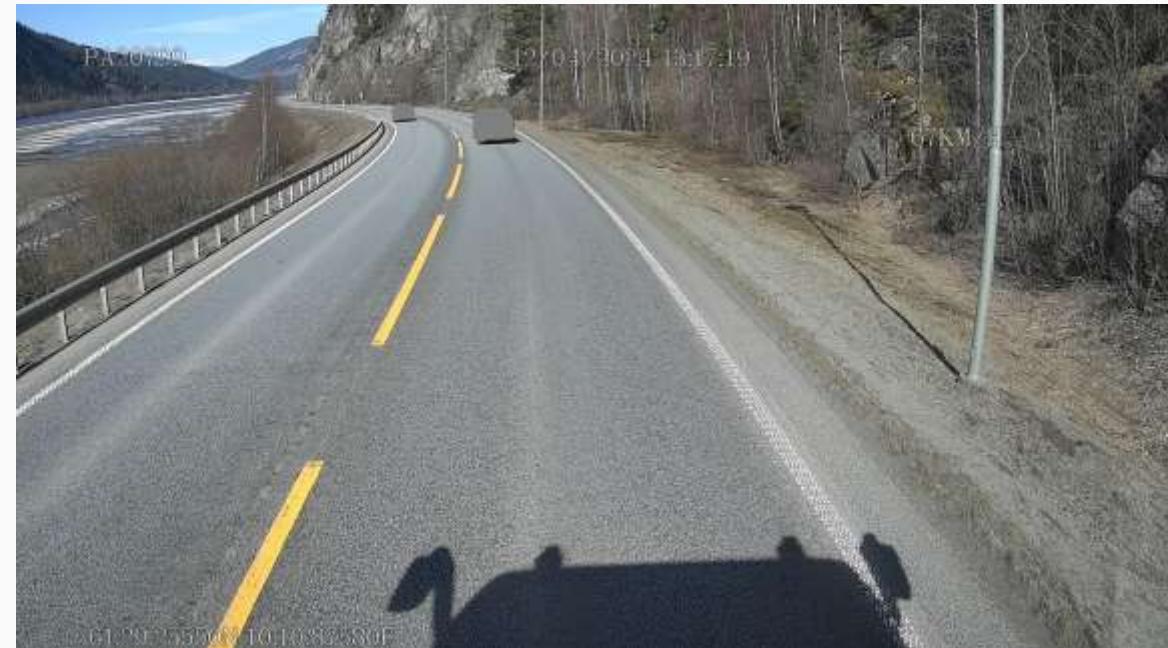
Filter Model

- Multi-Level Custom Model
- **Unsuitable image**
- **Segment Road surface**

Unsuitable Images
DELETE

Suitable Images
SAVE

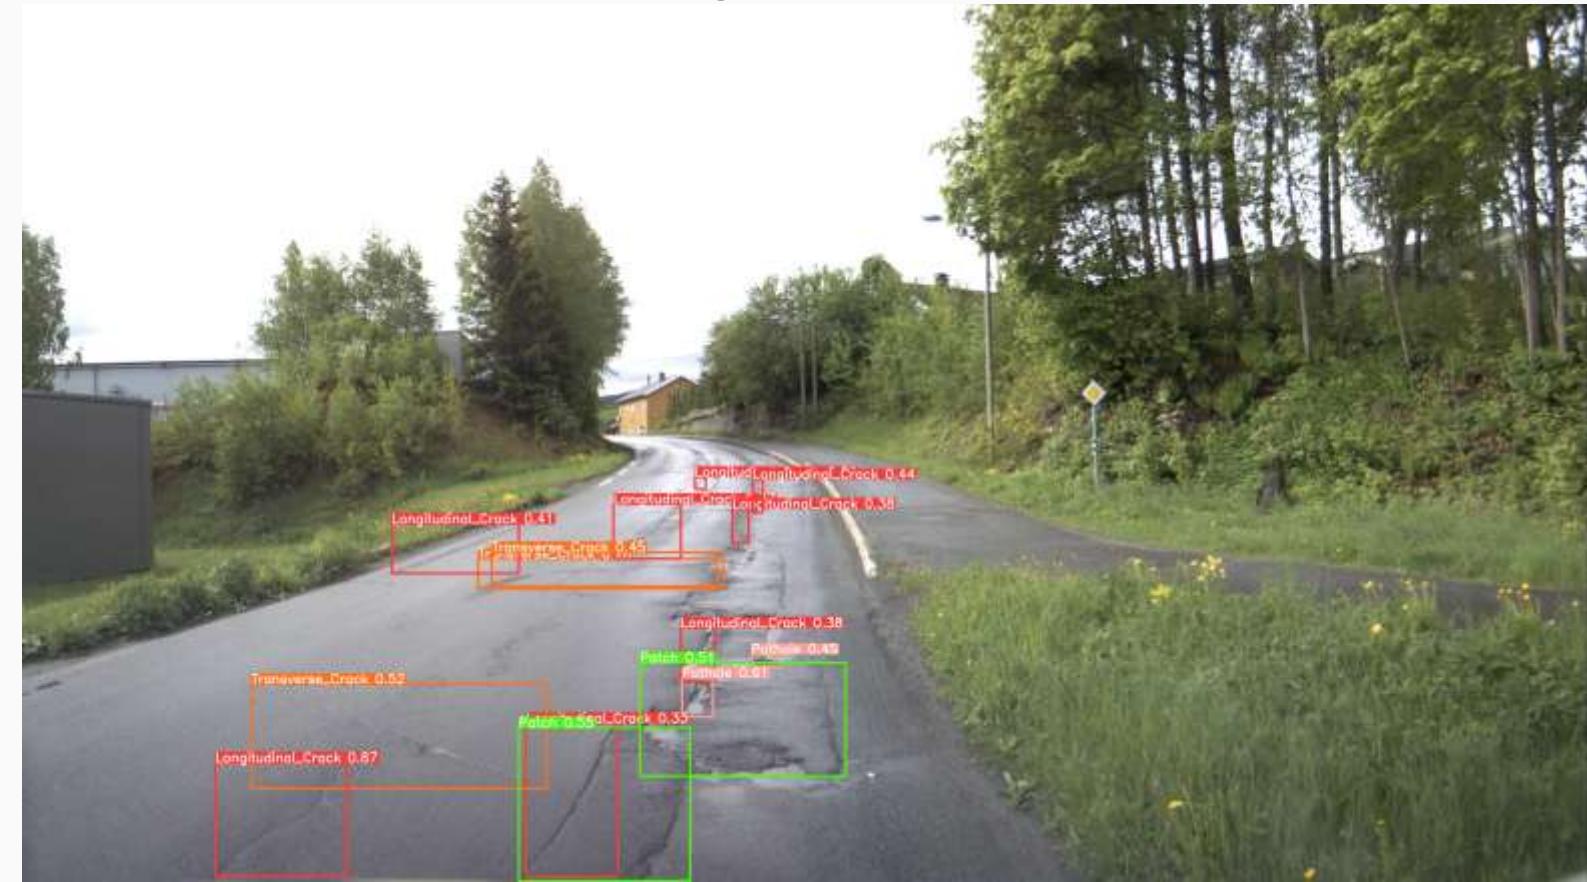
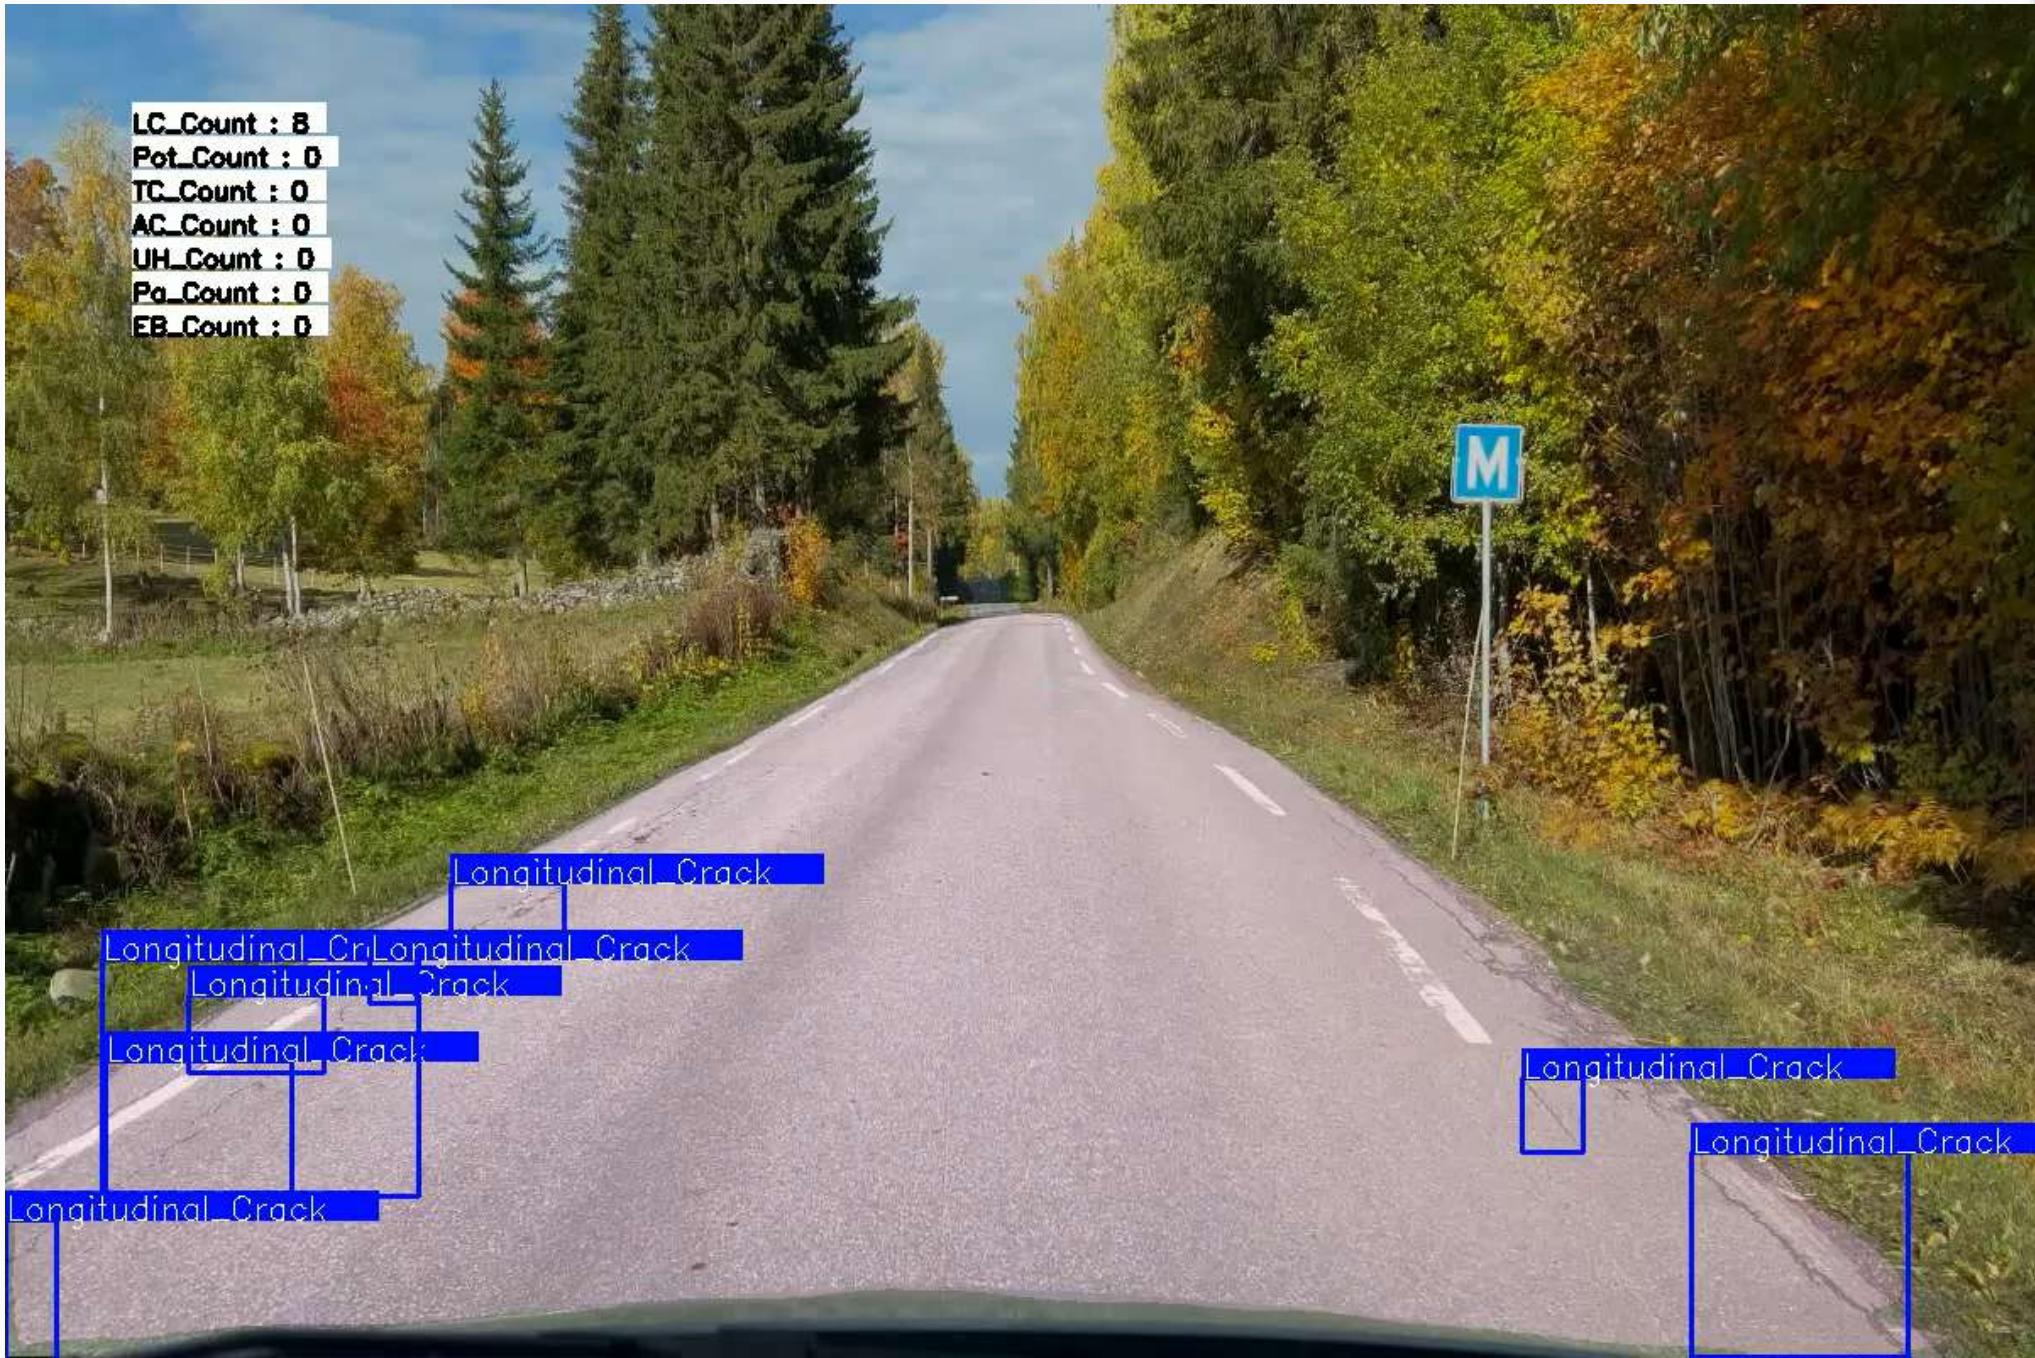
Road Damage Detection

- Detect multiple Road Surface Damages (Surface Distresses)
- **YOLOv11** and **Deformable DETR** model

Detected Road Surface Damages:

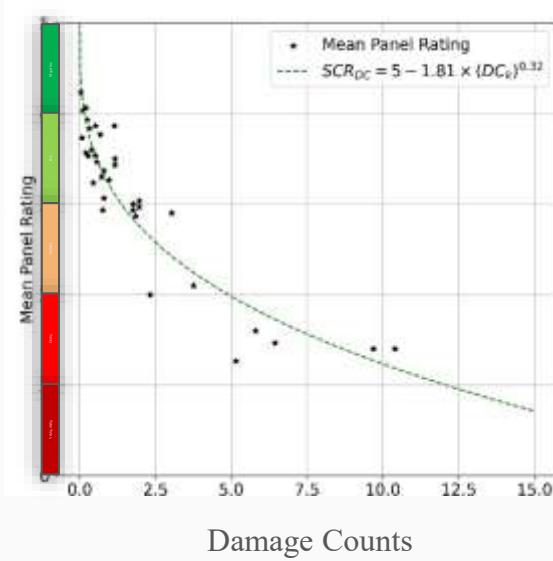
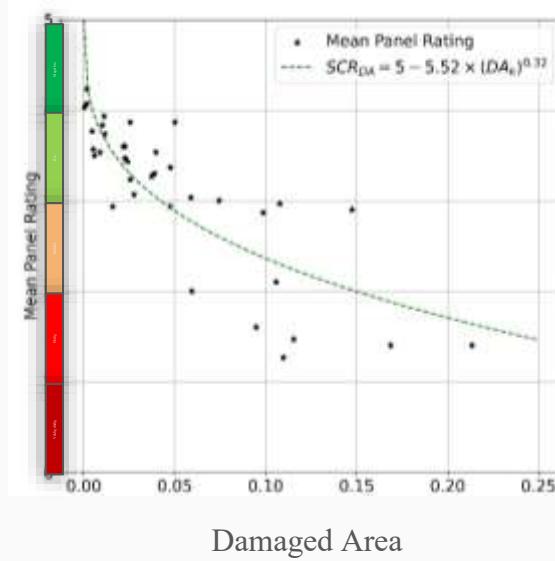
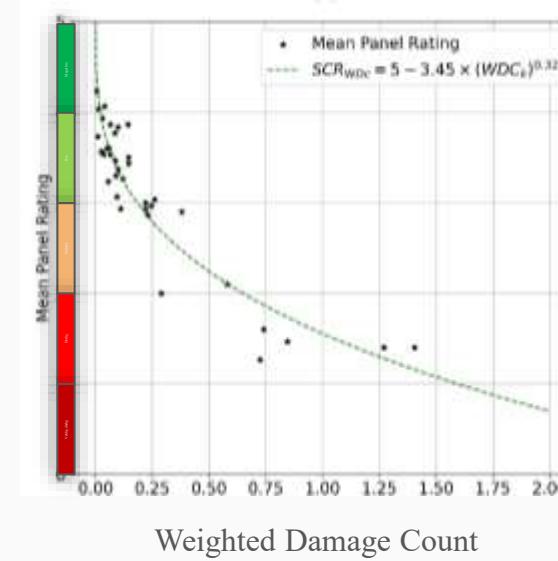
Section Condition Rating

$$SCR_{WDC} = 5 - 3.45 \times WDC_k^{0.32}$$

$$WDC_k = \frac{1}{n} \sum_{i=1}^n (0.125 \times DC_{LCi} + 0.125 \times DC_{TCi} + 0.25 \times DC_{ACi} + 0.5 \times DC_{POi})$$

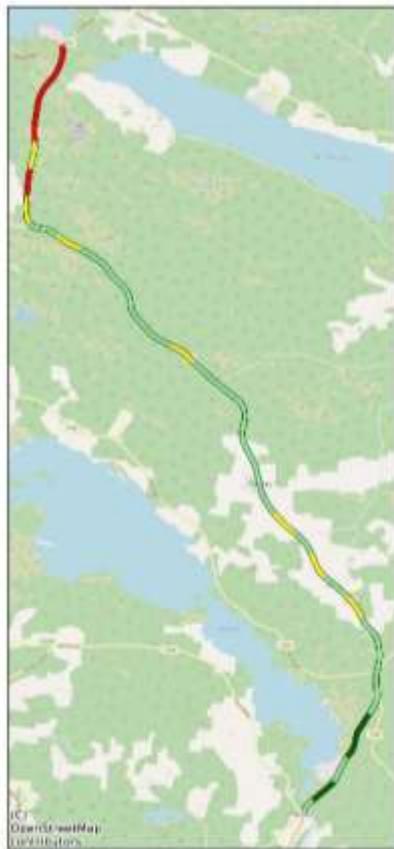
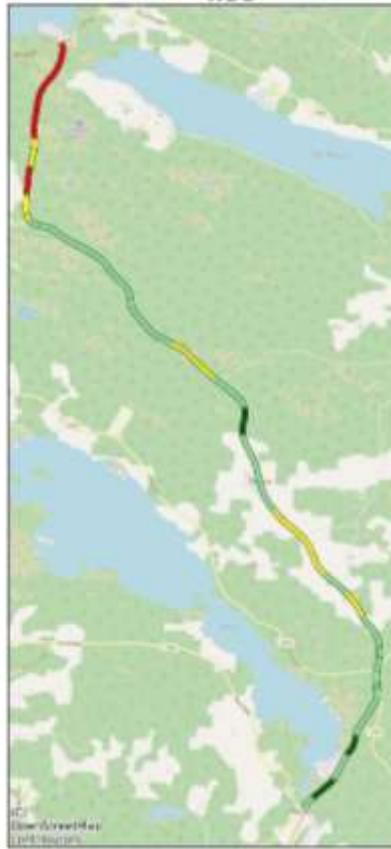
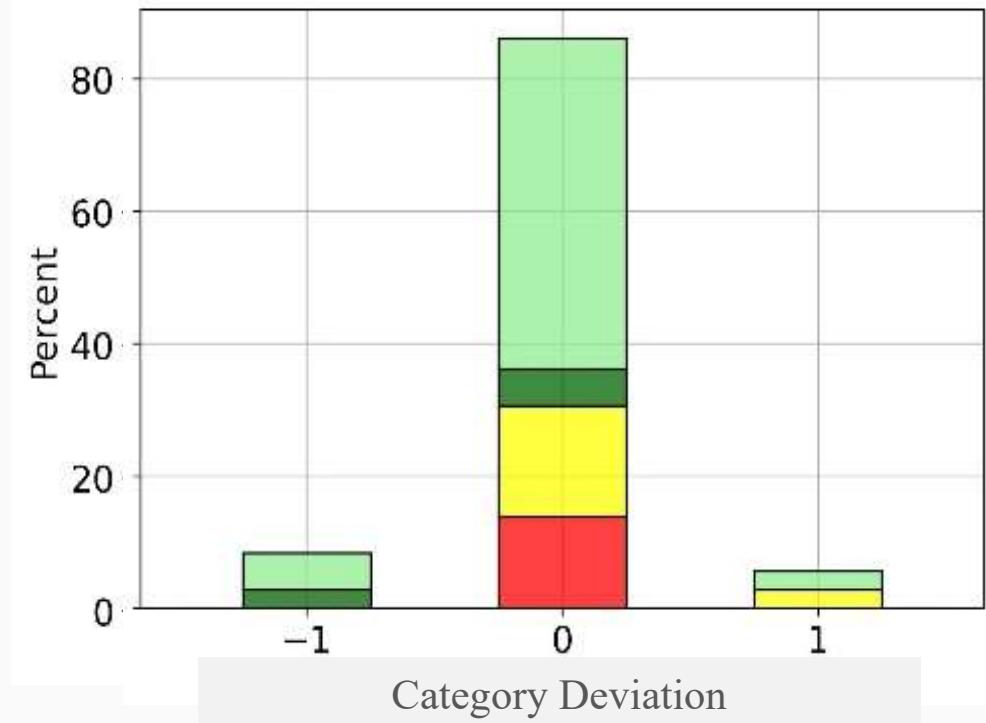
Section Condition Rating

Manual

Automatic

Very Poor Poor Satisfactory Good Very Good

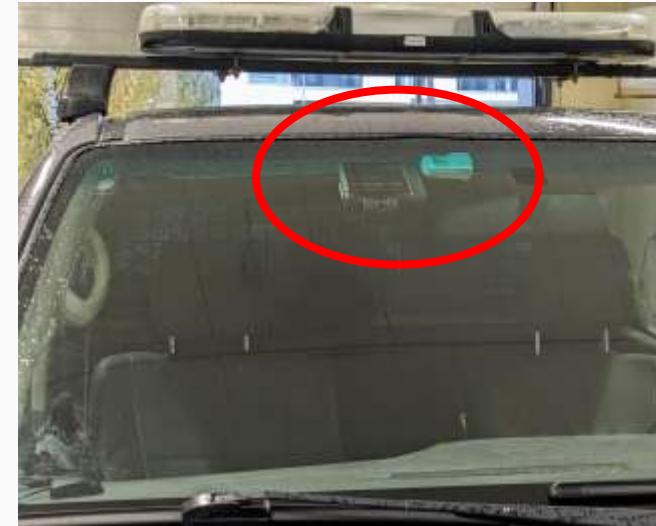
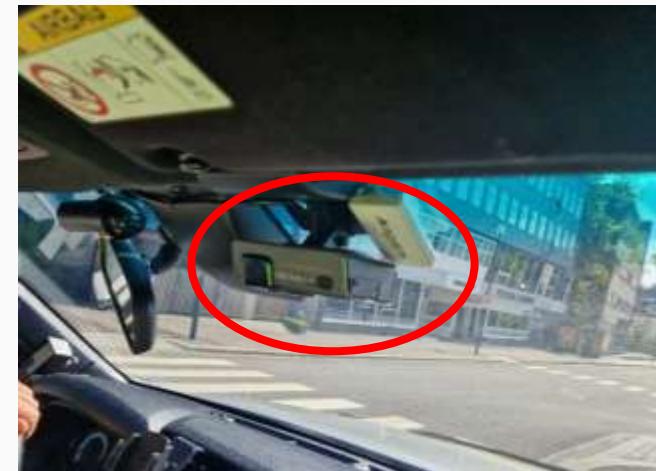
Pilot Study

- 2 Cameras on Buses and 2 on inspection Vehicles
- Around 3000 images/day

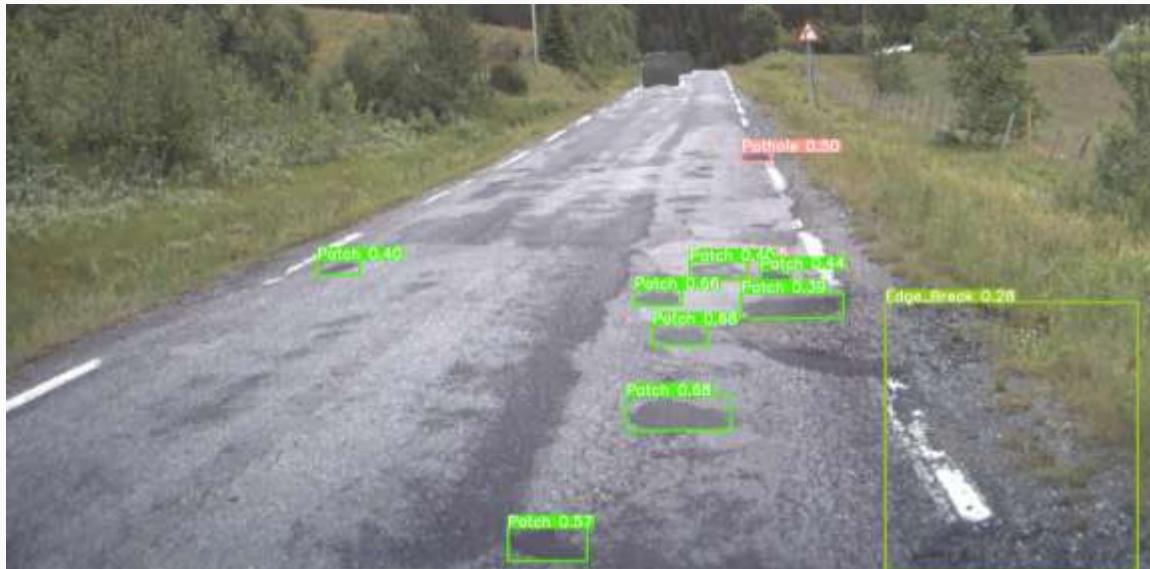
Camera Sensor: ViaPPS Front Camera
Damage Detection Model: YOLOv8-Large

Camera Difference

Reflections from Windshield

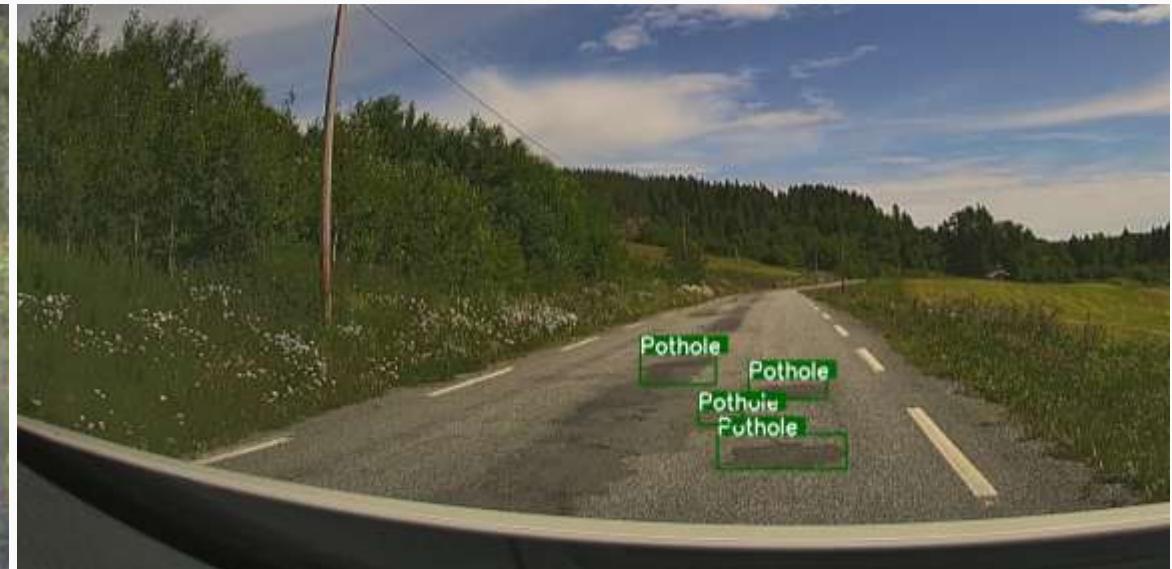
Camera Sensor: Streamax AD plus 2.0
Damage Detection Model: Deformable DETR

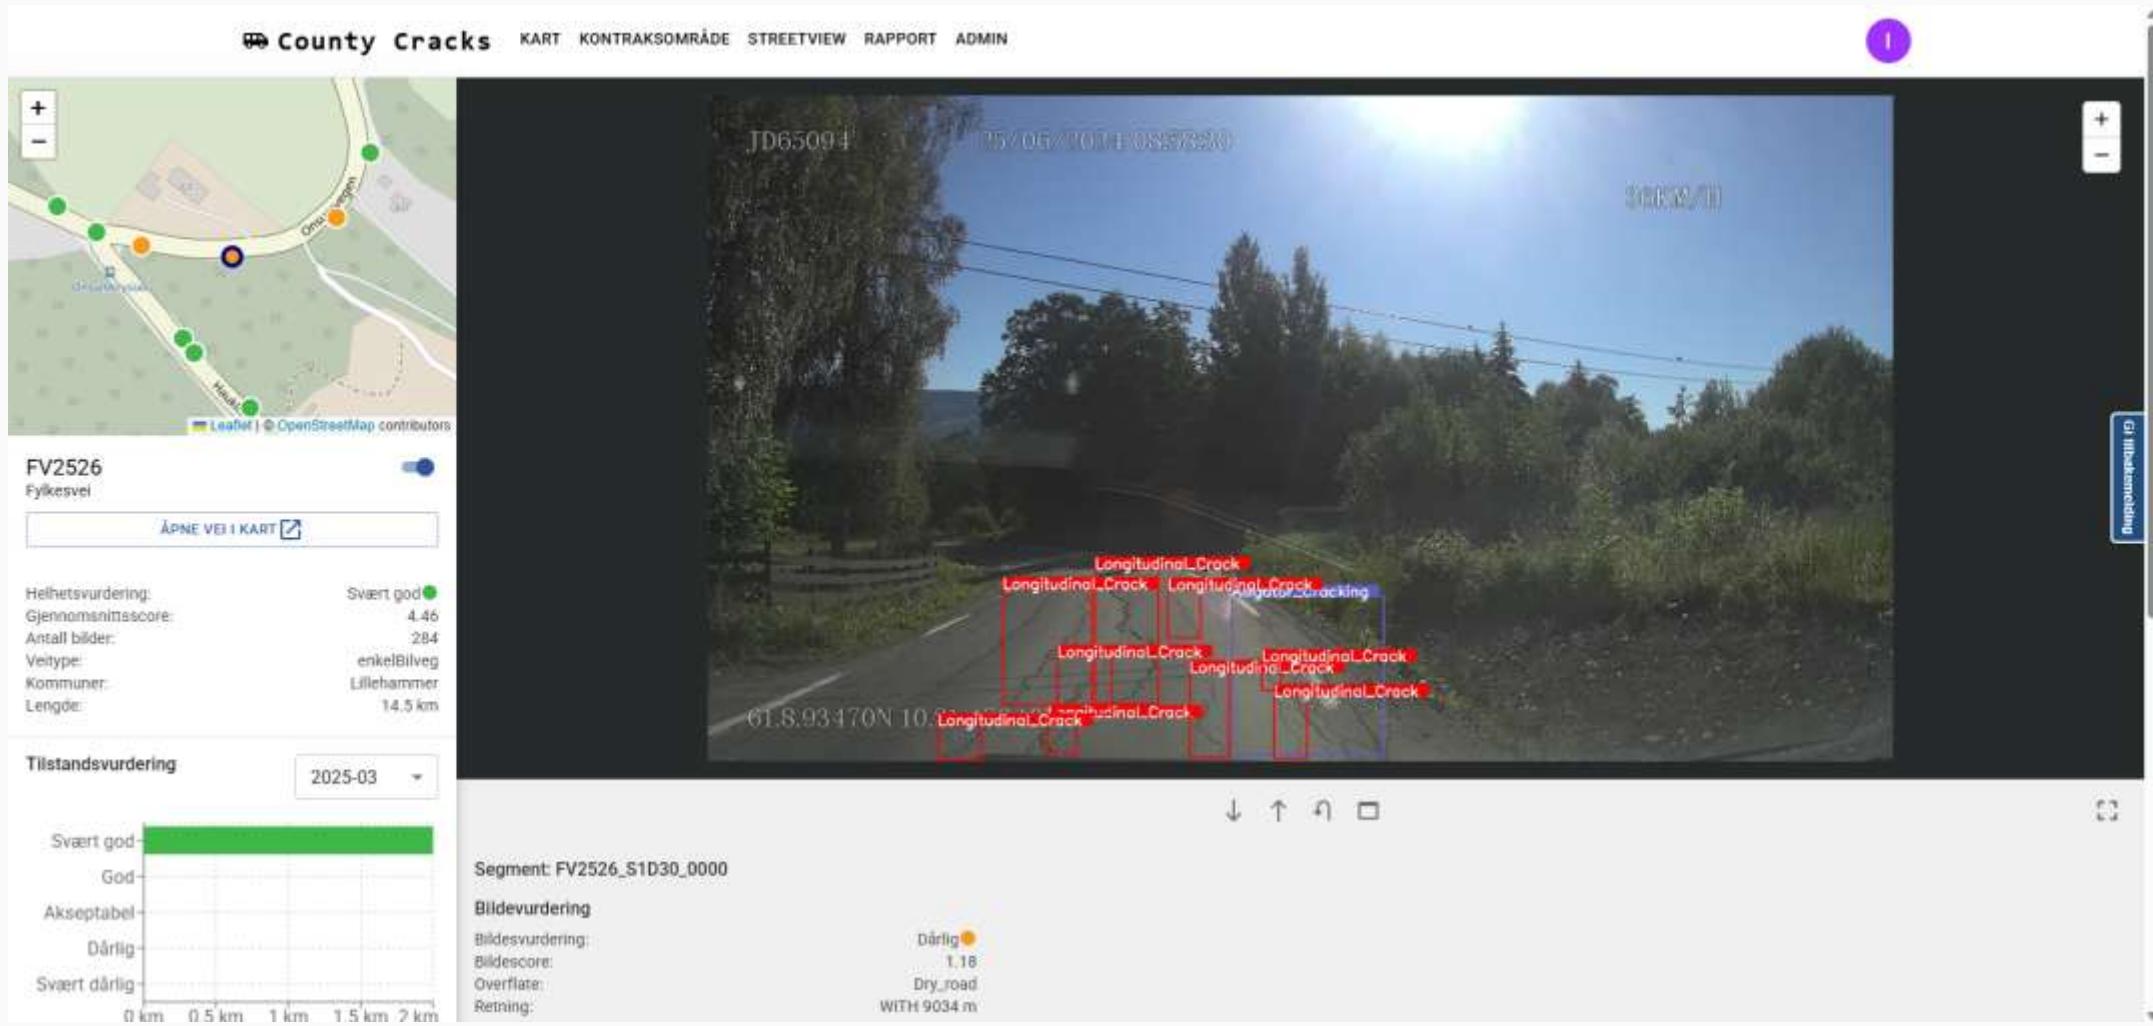
County Crack v1.0

County Cracks KART KONTRAKSOMRÅDE STREETVIEW RAPPORT ADMIN

FV2526
Fylkesvei

Helhetsvurdering: Svært god 4.46
Gjennomsnittsscore: 4.46
Antall bilder: 284
Veitype: enkelBilveg
Kommuner: Lillehammer
Lengde: 14.5 km

Tilstandsvurdering 2025-03

Svært god	God	Akseptabel	Dårlig	Svært dårlig
0 km	0.5 km	1 km	1.5 km	2 km

Segment: FV2526_S1D30_0000

Bildesvurdering: Dårlig 1.18
Bildescore: 1.18
Overflate: Dry_road
Renning: WITH 9034 m
